SOUTHERN MAINE COASTAL BASIN
YORK, MAINE

CHASES POND DAM
ME 00188

PHASE I INSPECTION REPORT
NATIONAL DAM INSPECTION PROGRAM

APRIL 1980

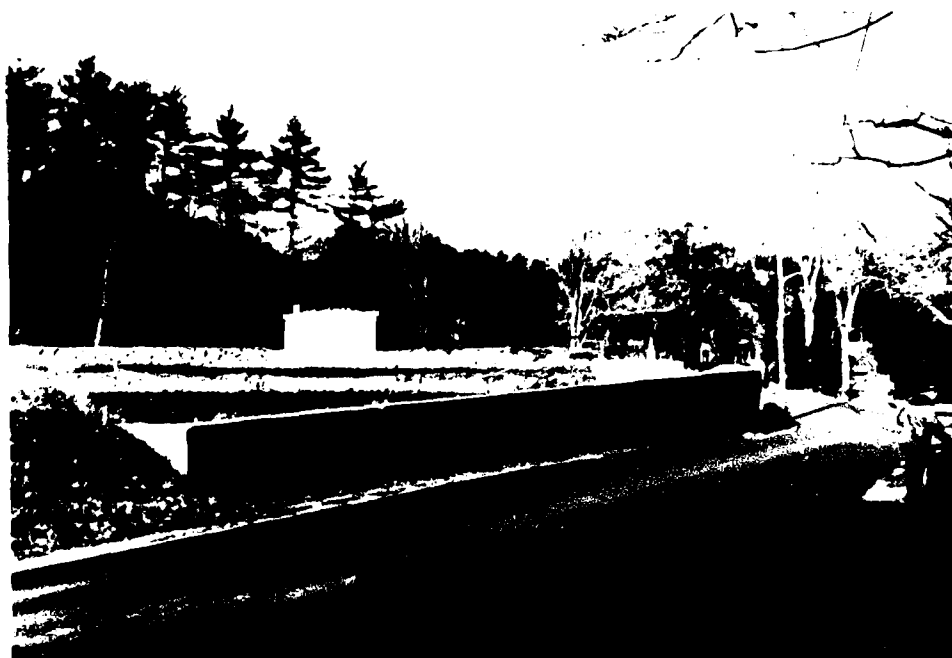
The right cantilever wall, Photo No. 10, evidences early signs of major deterioration of the concrete (see Appendix page A-5). Many of the wall panels have edge and joint deterioration, a longitudinal crack along the top surface of the wall, surface crazing of the concrete and/or efflorescence on the downstream face. The second panel from the spillway, Photo No. 11, appears to have shifted or tilted outward from the alignment of the adjacent wall panels. Other than the second panel, the alignment of the wall is good, Photo No. 6.

10. Cantilever wall, downstream

2. Determine the depth of surface deterioration of concrete elements and the necessity and means of repair.

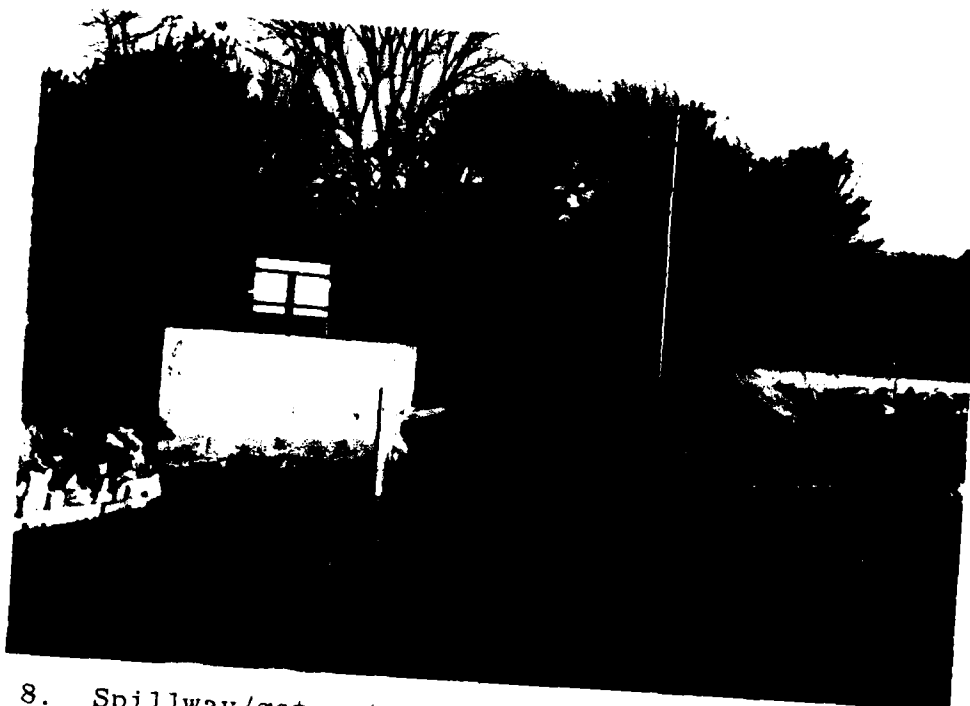
The spillway/gate structure, Photo No. 8, has a lightly eroded surface, but it does not appear to be of significance. There is a crack or opening near the spillway crest apparently where concrete placed for the 1950 reconstruction of the dam abuts the original concrete. Minor spalling, Photo No. 7, and areas of moisture were on the spillway surface but the conditions are not extensive. The upstream side of the intake or gate portion of the structure appeared to be a more recent placement of concrete and was in good condition. The downstream side of the structure, especially the lower regions, showed efflorescence, spalling, some cracking and general surface deterioration.

8. Spillway/gate structure, upstream

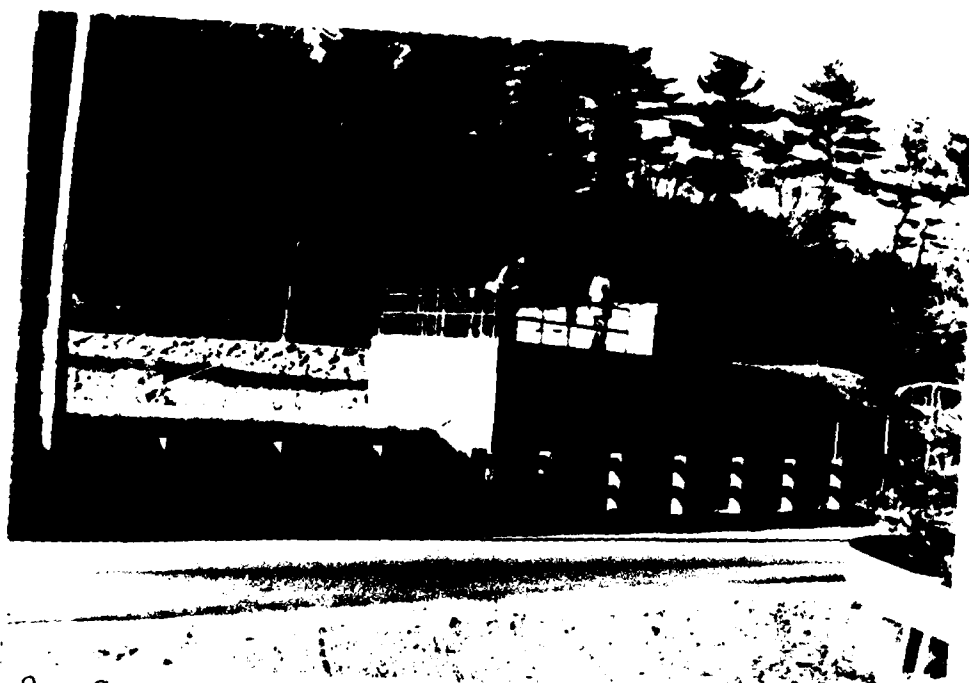
The visible portion of the gravity wall to the left of the spillway, Photo No. 9, has very pronounced surface deterioration in the lower region of the downstream face. Other portions of this wall have surface crazing, efflorescence and shrinkage cracks. The major portion of the wall's downstream side is covered by an earth fill shell with a well vegetated surface of mowed grass.

9. Spillway/gate structure and Chases Pond Road, downstream

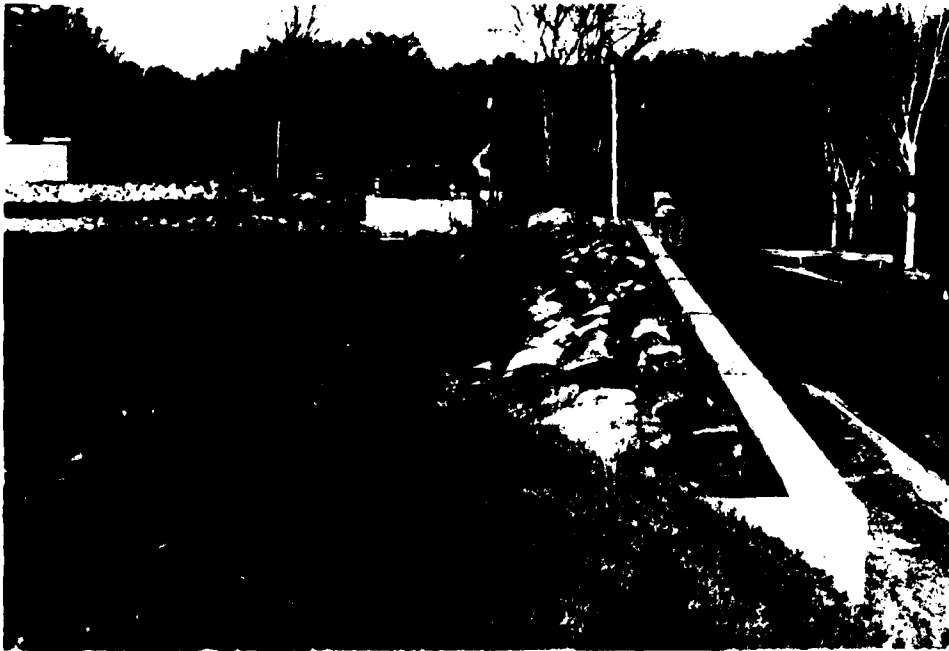
6. Alignment of right cantilever wall, spillway and left embankment

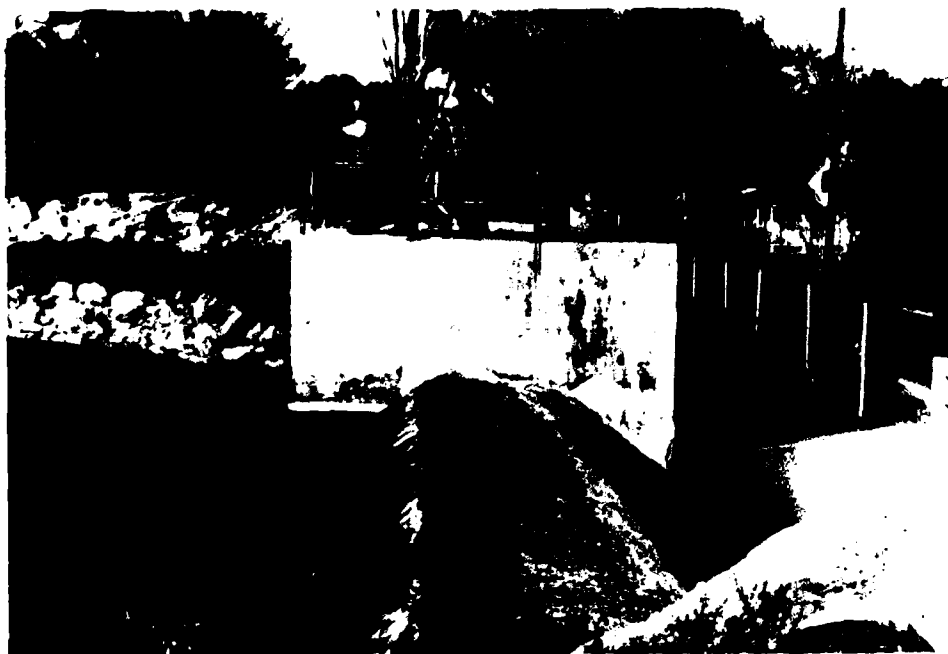
The top surface of the wall where it abuts the upstream side of the spillway is deteriorated, Photo No. 7. This low deteriorated area exposes the adjacent cantilever wall backfill to potential scouring during higher than normal discharges over the spillway.

7. Alignment of spillway/gate structure, from right side

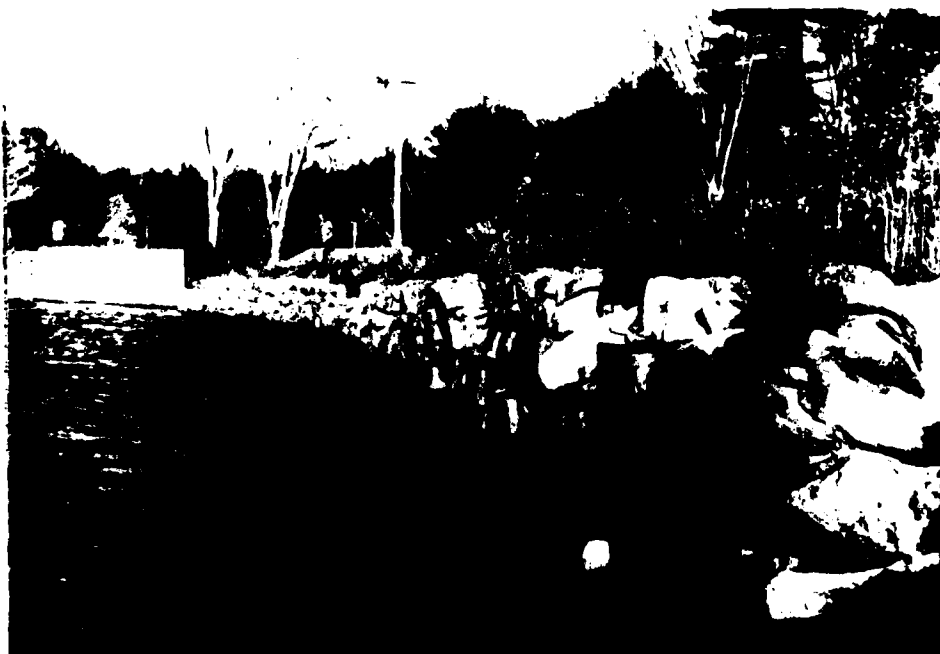
The upstream vertical stone wall at this section of the dam, Photo No. 5, is also in generally fair to poor condition. In several places, the stones have collapsed and in many areas they are out of alignment. Generally, the stone wall is in better condition within 50 ft. of the spillway.

5. Dry laid stone masonry along reservoir at right side

4. Rebuild the failed portions of the dry laid stone wall. A regular maintenance program to correct future localized failures of the stone wall should be developed.

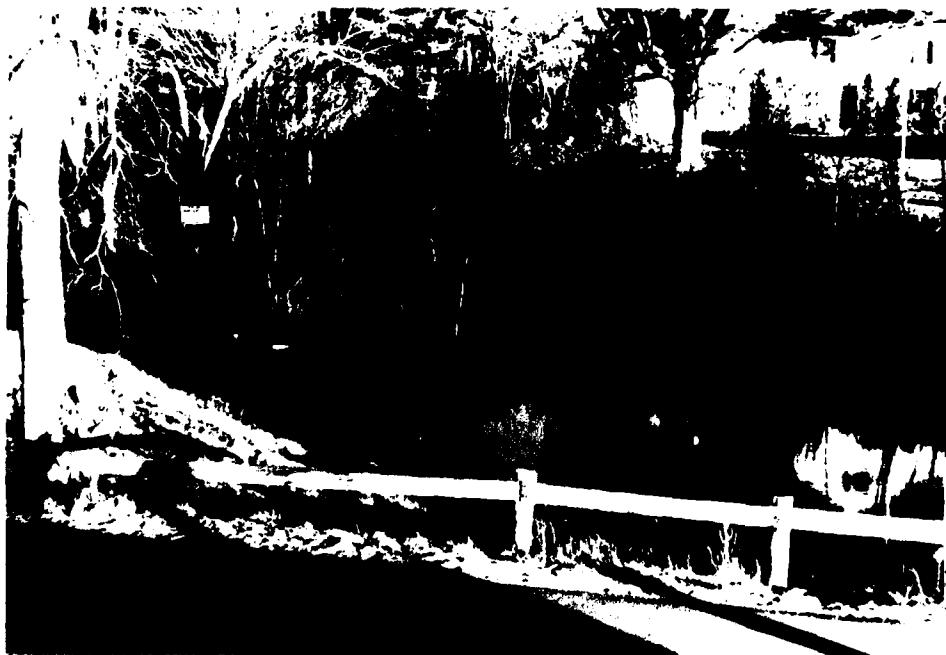
12. Little Pond and Little Pond Dam
